Easton's Beach Pavilions, Newport, RI Planning Study Final Report

November 1, 2022

with Recommendations

April 15, 2021 (final report)

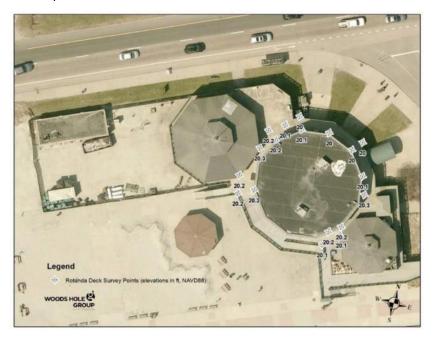
Figure 6: Critical elevations along the Deck surrounding the first habitable floor of the existing Rotunda.

The rotunda and proposed building could be severely damaged if this elevation is exceeded during a storm event. To determine the approximate level of resiliency associated with an elevation of 20 feet NAVD88 and applying a 50-year service life, still water flood elevations and maximum wave crests associated with a 1% (1 in 100-year occurrence) storm event under a projected 2070 climate horizon was utilized. The projected still water storm levels projected in a 2070 1% storm event are shown in Table 1 for both NACCS and the Massachusetts Coast Flood Risk Model (MC-FRM) storm surge models. The MC-FRM is the state standard for climate change planning and resiliency physics-based model that has been utilized for design guidance throughout the Commonwealth of Massachusetts and for the northeast. Although the MC-FRM does not include overland areas in Rhode Island, all water bodies, including Easton's Bay, are included for all of the northeast, and therefore, water surface elevations and wave heights along the shoreline of Rhode Island are included in the model. MC-FRM includes projected sea level rise dynamically in the model simulations, while NACCS only simulates present day conditions and simply adds a static value for the sea level rise projections.

Based on this comparison to both NACCS and MC-FRM, the critical elevation of ~20 ft NAVD88 will provide adequate resilience from flooding damage to the first habitable floor of the Rotunda and proposed new building. This elevation could support the continuation of vital functions and operations of the Rotunda, Carousel, and other amenities after the passage of storm events in conjunction, the proposed building should include an open ground floor allowing for potential flood water flow through, and the elevating and/or relocating mechanical equipment to the first habitable floor to further reduce damage to the proposed building. Lastly, the use of other flood proofing measures like flood barrier panels or perimeter barriers (if applicable) could further increase building resiliency for other buildings located on the property. Examples of flood barrier panels or perimeter barriers can be found on floodproofing.com's product website (www.floodproofing.com).

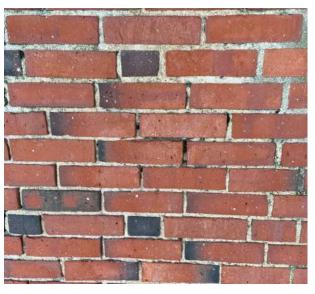
15. Areas on south facing elevations require repointing.

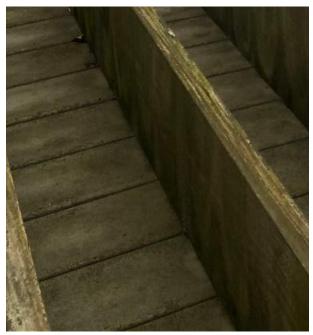
17. Rusting on painted steel ledgers under boardwalk.

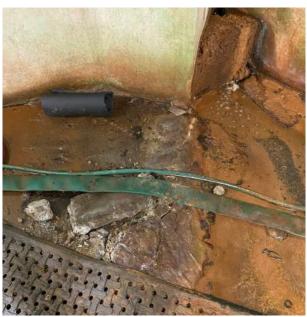
- 1. At the time of our visits, there was approximately 1" of standing water in much of the basement. The water appears to be coming in through the joints between the two basement spaces and through cracks in the foundation walls. (Image 21)
- 2. All of the exposed steel structure showed excessive amounts of corrosion, including steel components installed during a 1993 renovation.
 (Image 22)
- 3. This space contains the salinization and water treatment tanks for the aquarium on the first floor level of this building. (Image 23)

21. Water infiltration in basement

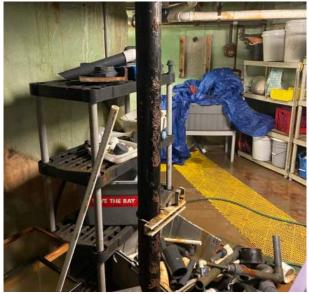
22. Corrosion on steel structure.

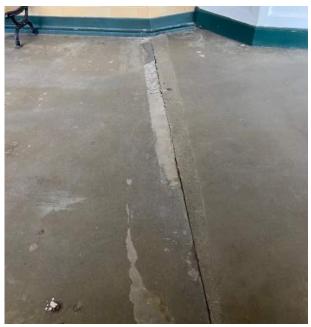
25. Cracking in slab-on-grade at first floor level.

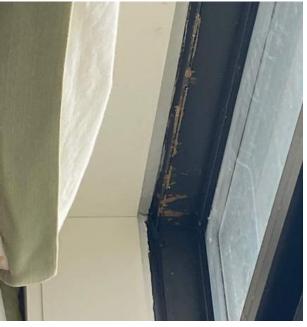
27. Result of water infiltration at window head.

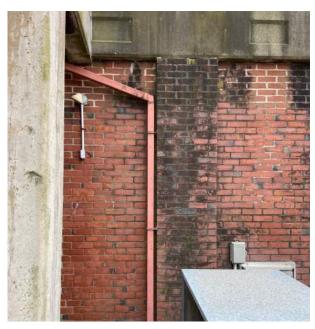
29. Black stains on masonry as a result of water drainage.

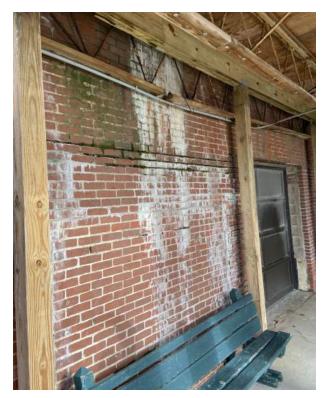
33. Efflorescence on brick masonry near overhead door.

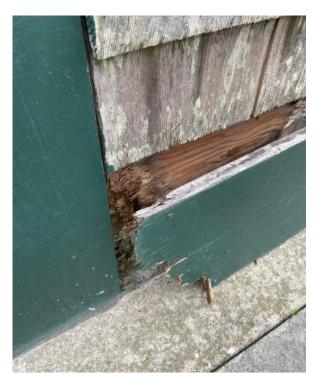
32. Deteriorated trim and sheathing behind it.

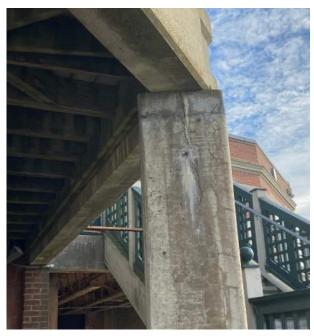
39. Cracking on concrete structure at second floor framing.

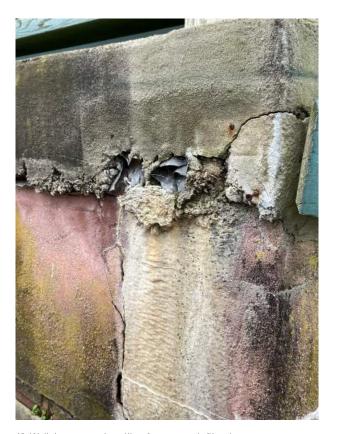
49. Wall damage and spalling from water infiltration

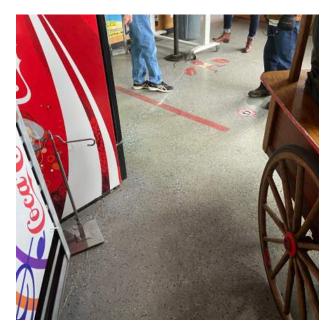
- 1. The second floor of this structure is octagonal in plan and has a smaller footprint than the first floor. The extra space at the second floor features a concrete deck, which is partially covered by a small wood shed.
- 2. There is a crack in the concrete floor slab that runs diagonally across the entire floor within the enclosed space of the Snack Bar. (Image 50)

50. Crack in the concrete slab.

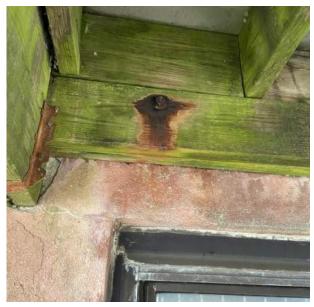
54. Rust colored water weeping through the ledger boards.

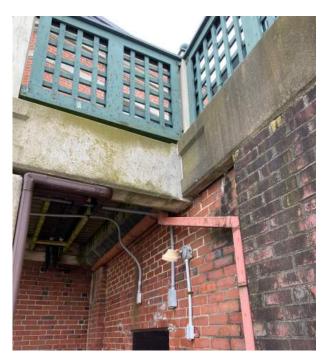
55. Structure has settled along outer edge of boardwalk.

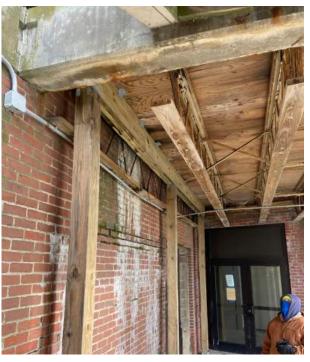
57. Extreme corrosion on painted steel bar joists.

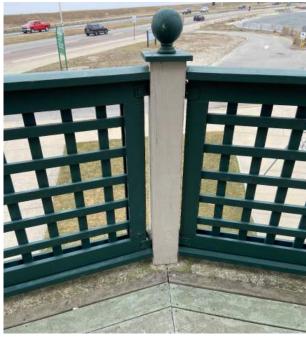
- 1. The railings at the edge of all the walkways and decks appear to have been installed as part of a renovation in the 1990s. They consist of 6" x 6" solid wood posts, six to seven feet on center with infill panels of lattice. The posts are capped with a wood board that is shaped to drain and in some cases with a decorative round wood sphere. (Image 60) The railing system is in poor condition, with many missing trim pieces, areas of deterioration, inferior materials used for its construction, and missing paint.
- 2. At the east side of the Snack Bar and leading to the south stair from boardwalk to grade, there are locations where sections of the railing are missing. (Image 61 & 62)

60. Typical railings along the edge of walkways and decks.

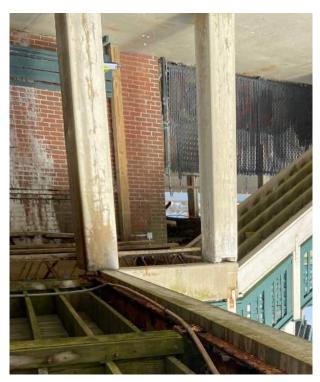
64. stairway providing access from grade level to boardwalk.

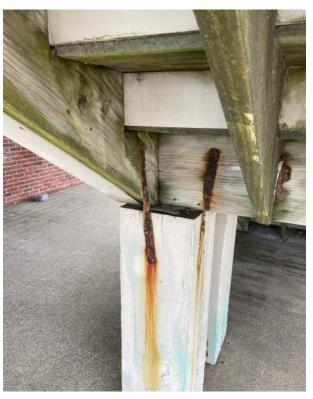
- 3. Some of the railings at the stairs are loose where the flange connects to the wood posts. These should all be tightened or re-anchored. (Image 63)
- 4. There are two stairways that provide access from grade level to the boardwalk. One is at the west end of the boardwalk and one is on the south side leading up to the Snack Bar. These stairs are wood framed with composite deck boards for the treads and risers. The west stair has a cast-in-place concrete portion from the grade to the first landing. Both stairs have galvanized steel railings from grade to the first landing and then the wood lattice guardrail system continues to the boardwalk level. The stairs are in fair condition, with minor repairs needed at the metal railings on the west stair. The strap anchors connecting the stair stringers to the wood post supports should be replaced due to corrosion. (Image 64 & 65)

65. The strap anchors connecting the stair stringer to the wood post supports should be replaced due to corrosion.

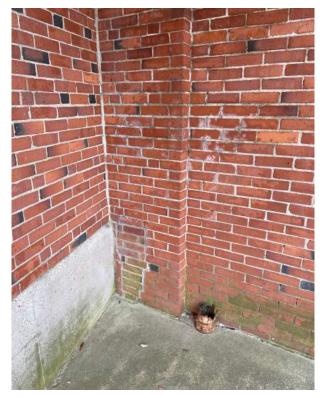
- 1. There are numerous settlement cracks in the sidewalks surrounding the buildings, but no serious differential settlement was noted.
- 2. The slope of the sidewalks away from the building should be verified to ensure that they are not contributing to water infiltration under the overhead doors.
- 3. There is an obsolete cast iron downspout boot outside a door leading into the Carousel building. This pipe is broken with jagged edges and is a safety concern. (Image 66)

66. Broken pipe with jagged edges presents safety concern.

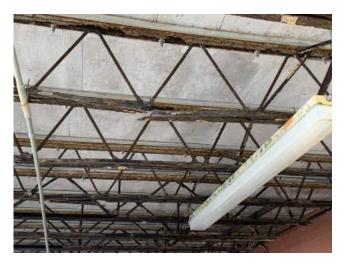
1.1b Severe Joist Deterioration

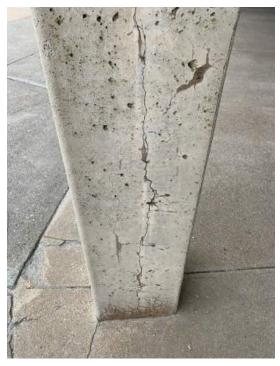
3.3b Cracks in Concrete Piers
