Caught Between the Ocean and a Watershed, Designing Climate Change Adaptations for Two Coastal Water Supply Dams in Rhode Island

Andrea Judge, PE, Fuss & O'Neill, Inc;

Abstract--The North and South Easton Pond Dams are interconnected, raw water supply reservoirs in the City of Newport, Rhode Island. The 12- to 14-foot-high earthen embankment dams, constructed within the footprint of former tidal wetlands in the 1870's and 1890's are classified as High Hazard potential dams, have a combined embankment length of 12,400 feet, and comprise a critical portion of the City of Newport's long-term water supply. The dams are adjacent to the Atlantic Ocean and are vulnerable to converging risks from extreme precipitation from inland storms, sea level rise, and coastal storm surge.

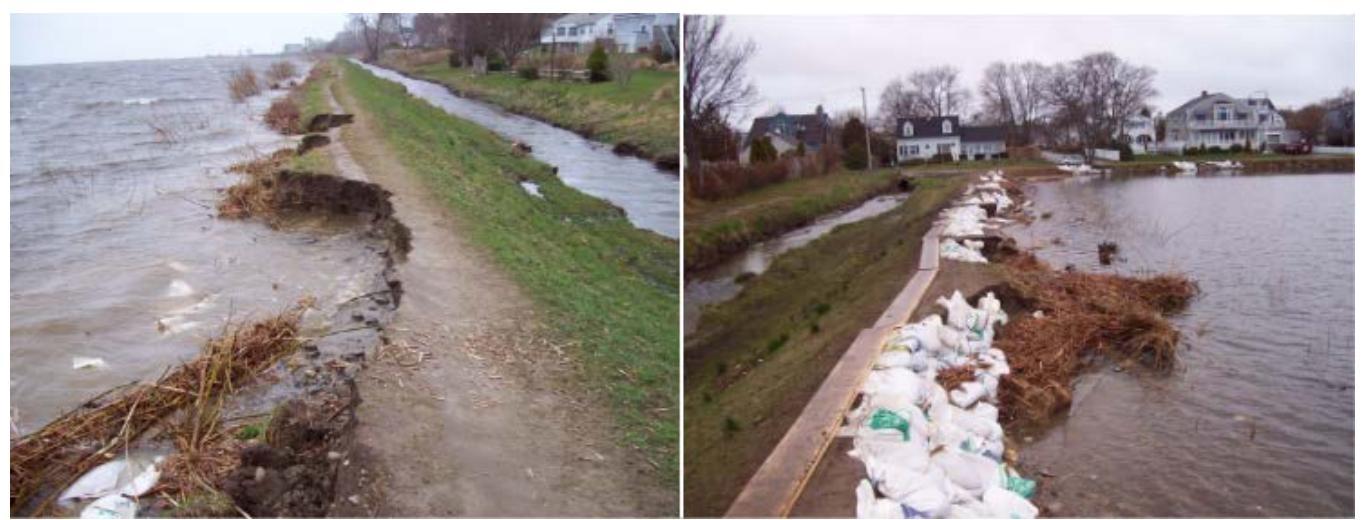
The region experienced significant hurricane flooding in 1938, 1954, and more recently damage during a Nor'easter in spring 2007 (Figure 5) that nearly breached the embankment and required emergency repairs. The damage was primarily on the west embankment and driven by erosion due to wind driven wave action. In some sections the embankment crest width was reduced to less than one foot. City staff hauled sandbags by wheelbarrow, and they were placed by hand to stabilize the embankment.

Figure 5: Flood damage at the west embankment of the South Easton Pond Dam after the April 2007 Nor'easter.

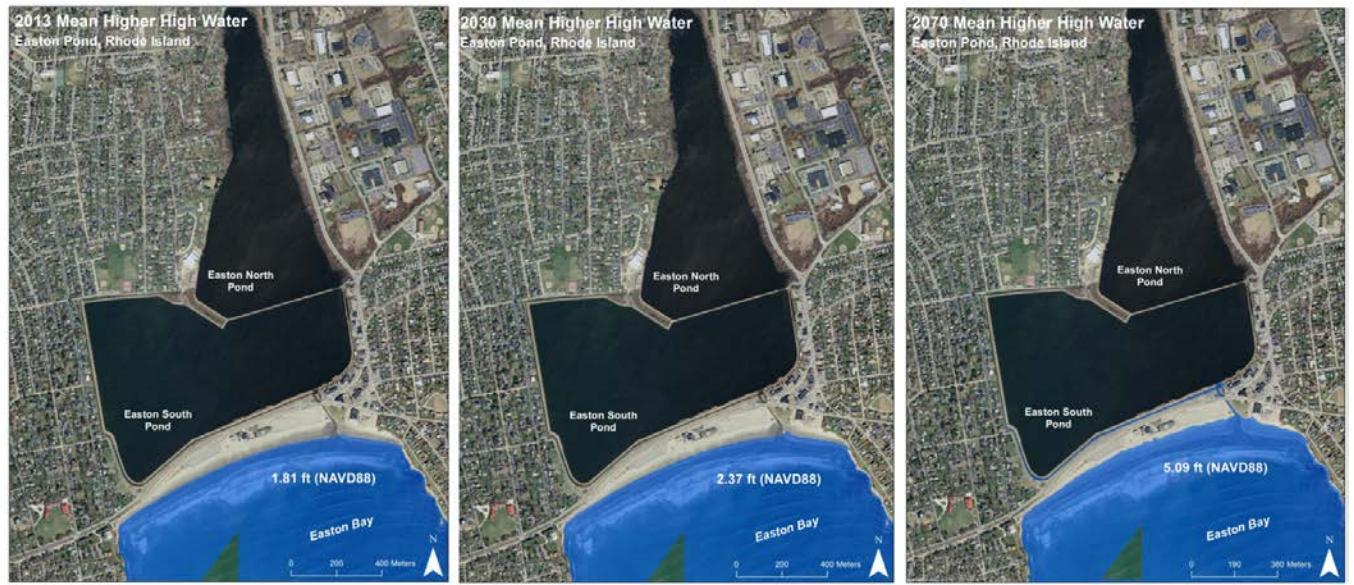
Figure 6: "Present Day" (2013) MHHW (left), 2030 MHHW (center), and 2070 MHHW joint probability inundation mapping.

As shown in Figure 6 and Table 1, the MHHW level is below the critical elevations at the dams, therefore sea level rise effects alone do not result in overtopping of the dam embankments or spillways. therefore, the South and North Ponds do not appear vulnerable to saltwater intrusion by overtopping during daily high tides. Storm

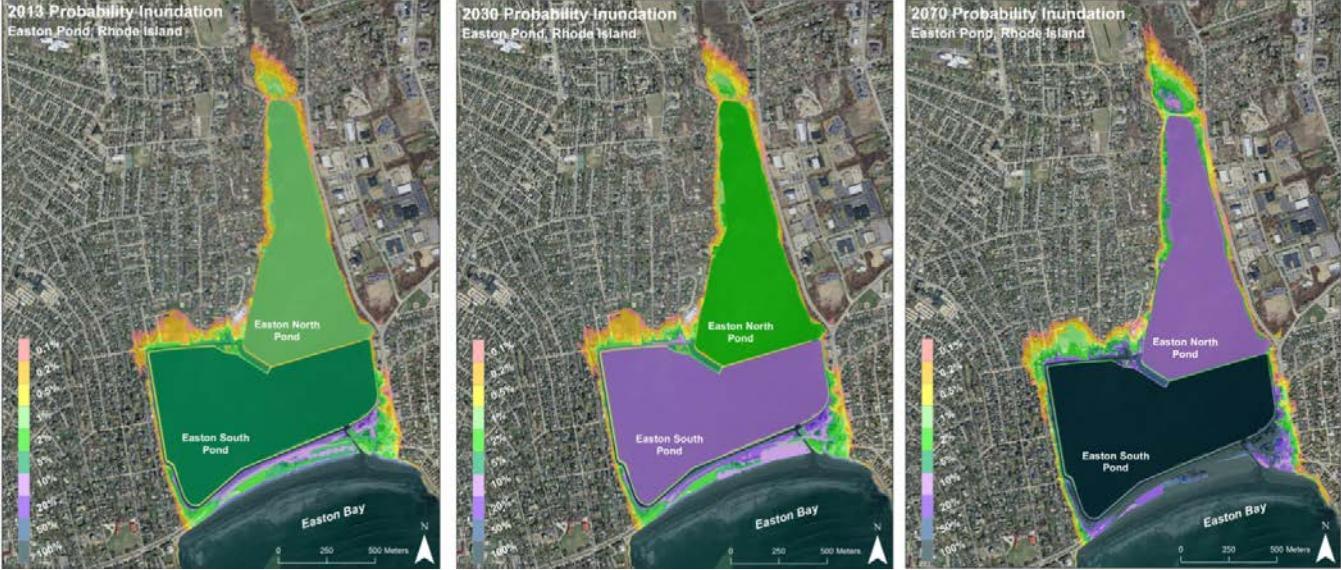
Figure 7: Joint annual chance of inundation for "Present Day" (2013, left), 2030 (center), and 2070 (right).

conditions would cause saltwater intrusion into both North and South Easton Ponds that could result in significant impacts to these water supplies (Figure 7 and Table 1).Table 2 indicates the following annual probabilities of flooding:

- Present day, there is a 5% annual chance of saltwater inundation at South Easton Pond and a 1% annual chance of saltwater inundation at North Easton Pond because of storm surge.
- By 2030, there will a 10% annual chance of saltwater inundation at South Easton Pond and a 2% annual chance of saltwater inundation at North Easton Pond, due to the combined effects of SLR and storm surge. By 2050, there will be a 20% annual chance of saltwater inundation at South Easton Pond and a 5% annual chance of saltwater inundation at North Easton Pond, due to the combined effects of SLR and storm surge.
- By 2070, there will be a 100% annual chance of saltwater inundation at South Easton Pond and a 10% annual chance of saltwater inundation at North Easton Pond, due to the combined effects of SLR and storm surge.

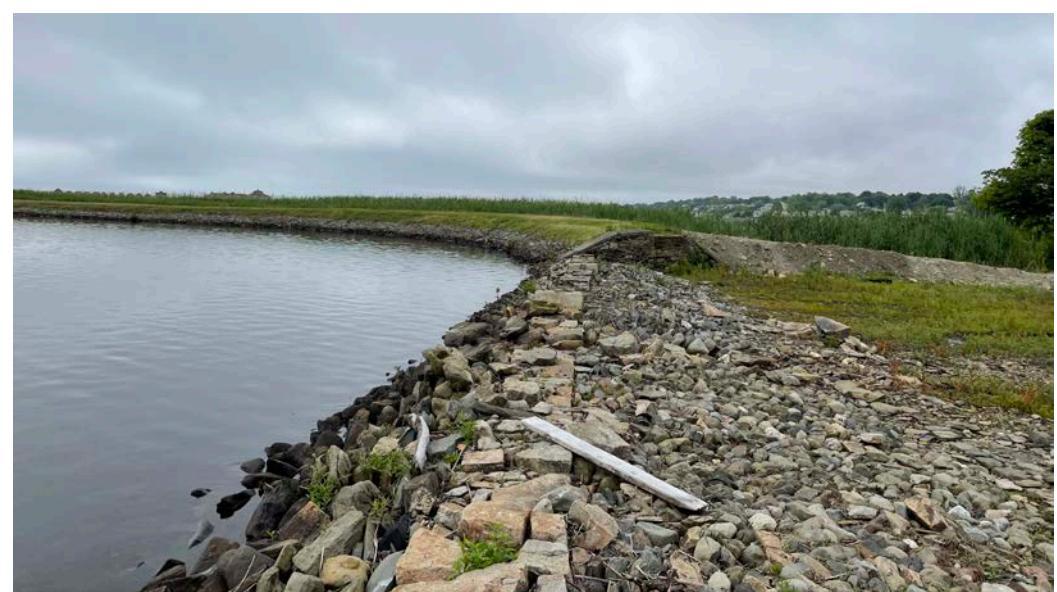
The RIDEM and City of Newport executed a consent agreement in March 2021 for the purpose of resolving the notice of violation issued in 2016 related to the poor condition rating at several City-owned dams. The City is required to repair the auxiliary spillway at the North Easton Pond Dam due to the poor condition of the spillway. The City intends to advance a comprehensive solution to improve the resilience of the dams against future intense coastal and inland storms, but the North Dam auxiliary spillway repairs were required before the plan could was developed. The design approach involved replacing the auxiliary spillway weir and training walls in-kind (similar length, weir crest height, weir configuration, training wall configuration) with cast in place concrete and restoring the existing stone armor in-kind (similar size, footprint) to streamline the environmental permitting and leverage existing H&H modelling, which demonstrates that the north dam is hydraulically adequate to convey the present day ½ PMF inland storm.

Figure 10: North Easton Pond Auxiliary Spillway

As described under the preferred alternatives above, a crest gate will be required for the North Easton Pond Dam secondary spillway to prevent flooding from future coastal storms. The exact elevation and design of the crest gate has not yet been finalized. Because of the likely future need of a crest gate, the secondary spillway was designed to allow it to be retrofitted in the future with a crest gate and minimize the need for substantial reconstruction of the spillway. The hand sketches in Figures 11 and 12 depict potential adaptations to the North Pond Dam auxiliary spillway. The rudimentary sketches were developed as part of a due-diligence workshop with the infrastructure design team including structural engineers, water resources engineers, and climate resilience specialists.
